Gypsum Mortars of the Khoja Zainuddin Mosque in Bukhara (Uzbekistan) – A Contribution to Building Archaeological Studies

Abstract: The Old City of Bukhara (Uzbekistan), protected as UNESCO world cultural heritage, is one of the most important historical urban fabrics in Central Asia. In the northwest of the city lies the Khoja Zainuddin Mosque – a monument of overarching art historical importance and an outstanding state of preservation. A building archaeological survey has shown that the whole building was erected in one single phase in the middle of the 16th century [1]. However, several later modifications can be clearly determined in the prayer hall and the adjoining rooms. For the classification within the historical context, a detailed analysis of the mortars was executed. Pure gypsum, gypsum-lime and clay mortars were identified. In some samples, the analyses also provided evidence of organic additions, probably to improve the mortar's properties.

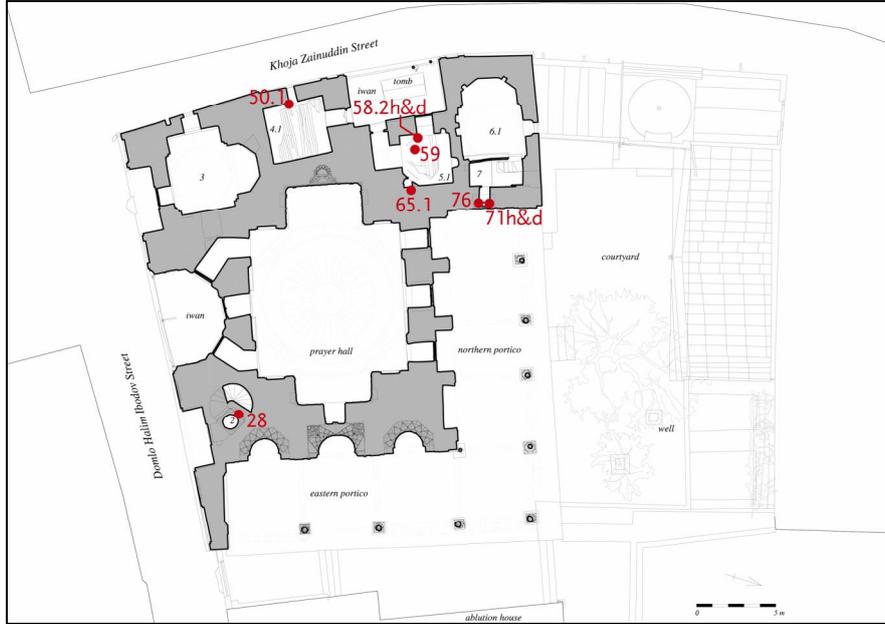
Fig. 1 First floor plan of the Khoja Zainuddin Mosque with sampling locations

The Khoja Zainuddin Mosque (Fig. 1) is dominated by a domed prayer hall that is surrounded by a wooden portico in the north and east. The western part of the building is occupied by four small rooms and a monumental niche with the tomb of the saint Khoja Zainuddin.

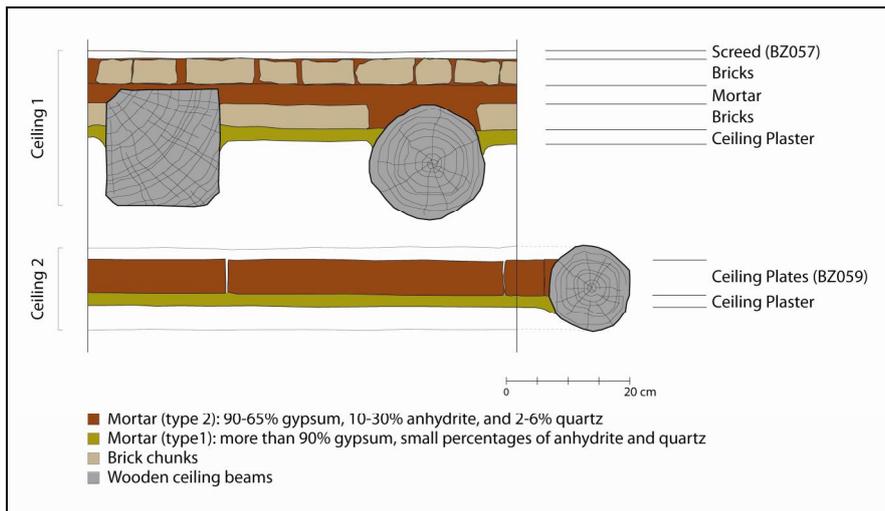
Fig. 2 Cross section of the ceiling construction in room 5

A particularly interesting element is represented by the ceiling construction in room 4 and 5 (Fig. 3): In between the wooden ceiling beams, brick chunks are fixed with different layers of very delicate mortars. This construction is covered from both the upper and lower side by further layers of mortar. In room 5, a second ceiling was constructed under the original one that burnt through to some extent. Substantially, the same construction system was applied for the new ceiling; the only difference is the usage of mortar plates (Fig. 2) in place of the brick chunks.

In table 1, examples of the five defined groups are briefly presented. The results show the composition of the mortars and the percentages of crystalline components. However, some samples show additional features. Three samples have been chosen for further analyses. Sample BZ028, a joint mortar, was taken on the exterior of the building, BZ059 from one of the mortar plates in the ceiling construction (Fig. 2). Sample BZ065.1 represents a pure gypsum mortar which was affected by heat.

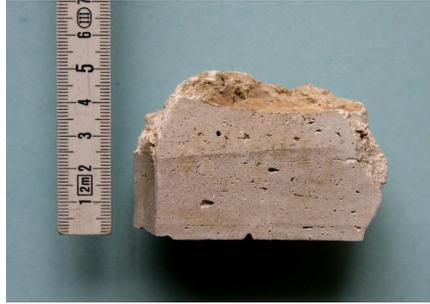
Fig. 4 Mortar sample taken in room 7

Also the niche in the east wall of room 7 marks a special point of interest. The original opening towards the northern portico was later closed with reused mortar chunks (Fig. 4) that still bear traces of ornaments and paintings.

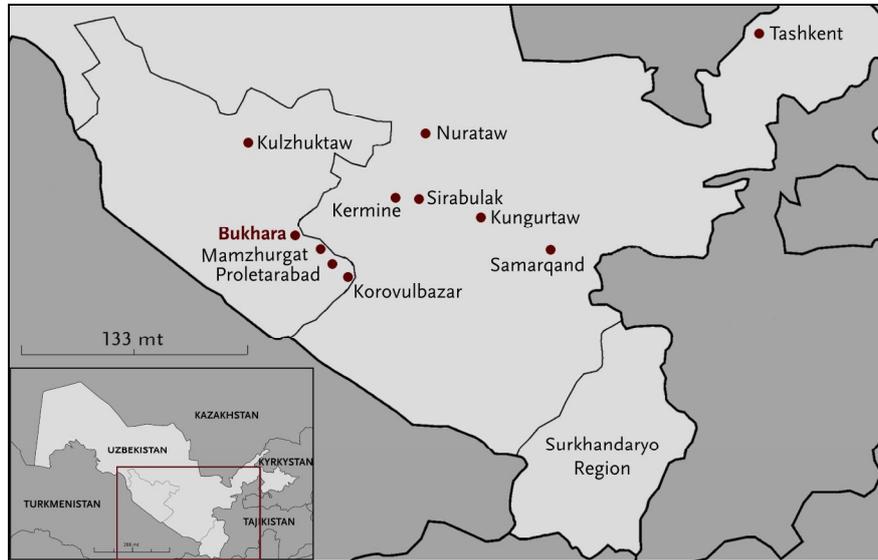
Fig. 5 Gypsum, celestine, quartz and limestone deposits in the region of Bukhara

An overview shows the most relevant raw materials and their deposits in the region of Bukhara (Fig. 5).

Gypsum and anhydrite: Large Paleogene gypsum deposits are situated in Mamzhurgat (thickness 4-15 m) [2, 3] in the region of Kagan, about 12 km southeast of Bukhara. This gypsum is of white or greyish-white colour, fine-grained and crystalline.

Celestine: Beside the deposits of the Fergana Valley another celestine deposit is situated in the Surkhandaryo Province within sulphur deposits [4].

Quartz: A large deposit (thickness 18 m) of very pure quartz (content of SiO₂ is up to 99,3%) is situated in Tozbulak in the southern Kulzhuktaw Mountains. The deposit of Bitab in the southern mountains of Nurataw also contains microcline deposits, convenient for the production of fine ceramics [2, 3].

Limestone: The deposits of Korovulbazar (about 43 km in the southwest of Bukhara) and Proletarabad (about 25 km in the southwest of Bukhara) are characterized by grey or greyish and fine grained limestone [2, 3].

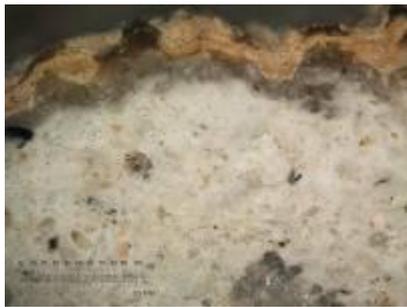
Fig. 6 Sample no. BZ028, 50x

BZ028 (Table 1, Fig. 6): The white outdoor gypsum mortar shows moderately sorted grains in a homogeneous matrix with low porosity. The aggregates consist of natural xenomorphic and partly idiomorphic gypsum and anhydrite crystals (approximately 80%) measuring up to 0.2 cm.

Using FTIR microscopic spectroscopy, a residue of the organic add-on could be identified. The extraction of the powder using organic solvents (methanol, methyl ethyl ketone) resulted in a mixture of long-chain unsaturated fatty acids, calcium oleate and protein. The spectrum of substances is a strong hint for the addition of an organic compound. Most probable is the add-on of whey. The organic modified binder might have been used to refine the plaster and to improve its properties. The detected oxalates are assumed to be the result of the microbially induced corrosion of calcite forming a precipitation of calcium oxalate underneath the surface layer of secondary precipitated gypsum.

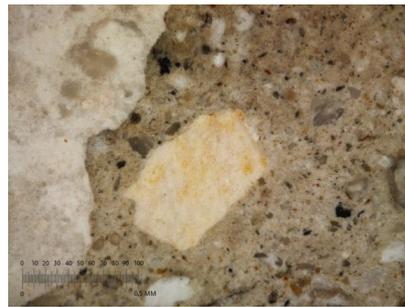
Fig. 7 Sample no. BZ059, 50x

BZ059 (Table 1, Fig. 7): the FTIR-spectrum bears great resemblance with sample no. BZ028. The occurrence of calcium oxalate in combination with calcium oleate and proteins indicates the use of whey.

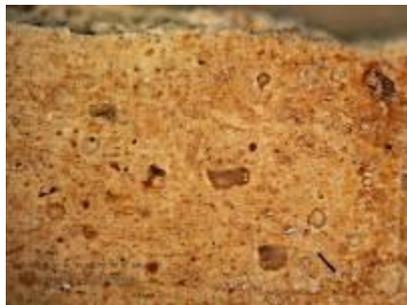
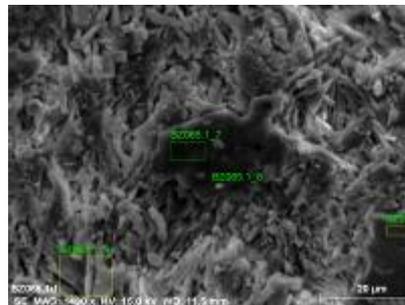
BZ065.1 (Table 1, Fig. 8): This sample represents an extremely pure and homogeneous gypsum mortar of very low porosity. Only few gypsum crystals were added, measuring up to 0.5 cm. Celestine was detected in the sample using SEM and EDS. The yellowish-brownish colour of the white mortar is a result of its location at the bottom side of a chimney opening [5].

Fig. 8 Sample no. BZ065.1, polished section, 50x (left), SEM image (right)
